# **Replacement of fuel pumps for ROTAX**<sub>®</sub> **Engine Type 912** (Series)

ATA System: 73-00-00 Fuel system

Replacement of fuel pumps for  $ROTAX_{\mathbb{R}}$  engine type 912 (Series).

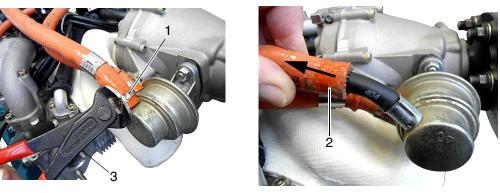
Fig. 3

Cut the band clamp:

Slide back fire sleeve:

Pinch rubber hose to prevent fuel leakage:

Part	Function	
1	Band clamp	
2	Fire sleeve	
3	Cutting pliers	
4	Hose pinch pliers

Step	Procedure
1	Cut off the 1-ear clamp (1) of fire sleeve (2) with cutting pliers (3).
2	Slide back the fire sleeve (2) to make fuel hose accessible for cutting.
3	Pinch off the fuel hose with hose clamp pliers (4).

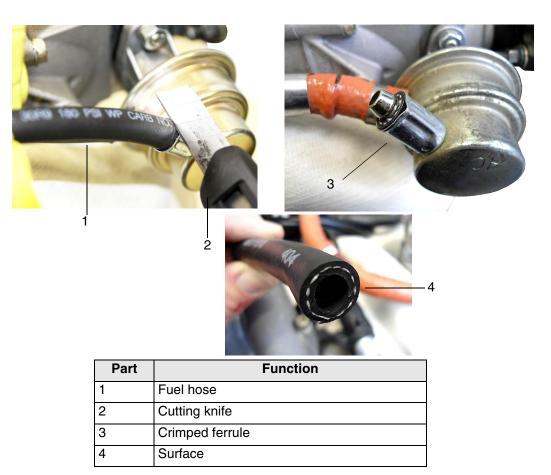
Fig. 4

Cut off the fuel hose with a very sharp knife, so that no cutting residues are produced. See Fig. 4. Risk of cut injuries! Knives are sharp and may cause injury.

Step	Procedure		
4	The cut should be made adjacent to the crimped ferrel, to avoid losing any needed length. The fuel hose is reduced by approx. 20 mm (0.79 in.).		
	NOTE: Make note of orientation of the hoses (inlet/outlet) A clean cut surface is very important!		
5	Repeat procedure at the second fuel hose assy.

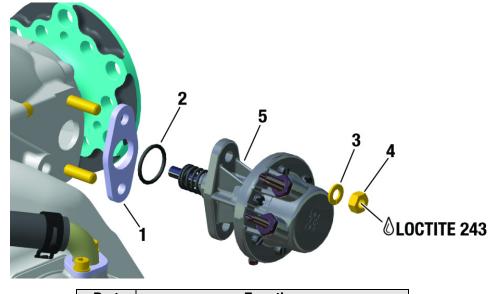
Fig. 6

Part	Function
	1	insulating flange (gasket)
	2	O-ring
	3	Lock washer A8
Ī	4	Hex. nut M8
	5	Fuel pump assy.

See Fig. 6.	-		
NOTICE		In addition to the insulating flange (gasket) also replace the O-ring at reas- sembly or assembly of the fuel pump. Both parts are included in the set of fuel pump assy.	
NOTICE		Ensure the O-ring is located in the recess in the fuel pump, before in- stalling the fuel pump!	
NOTE:		Also all work has to be carried out in accordance with the aircraft manu- facturer's instructions	
Step		Procedure	
1	Install fuel pump (5) with new insulating flange (gasket) (1) and O-ring (2).

them evenly. Tightening torque 15 Nm (133 in.lb).

Secure new hex. nuts M8 (4) and lock washer A8 (3) with LOCTITE 243 and tighten

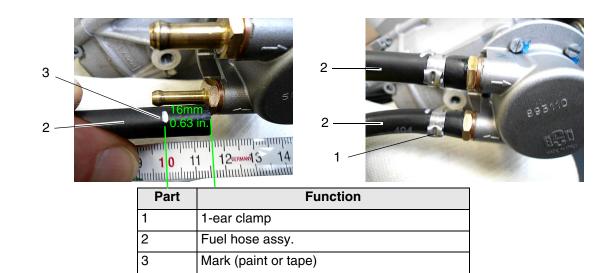
Fig. 8

Step	Procedure		
2	Before the fuel hose (2) is fitted with a 1-ear clamp (1), the two fuel hoses have to be marked (3) 16 mm (0.63 in.) from the end of the hose (2).		
3	Slide all 4 1-ear clamps (1) on the fuel and fire sleeves.		
	NOTE: Clamps part no. 853313/851663 on fire sleeve and clamps part no. 851463/851453 on fuel hose.		
4	Slide the fuel hoses (2) onto nipple completely up to the end stop.		
5	Crimp 1-ear clamp (1)- outlet side part no. 851463 with suitable crimp pliers .		
	NOTE: The edge of the 1-ear clamp (1) must align with mark (3) from fuel hose (2), because otherwise there is too little space for the 1-ear clamp (1) of the fire sleeve.		
6	Repeat steps on inlet-side with 1-ear clamp (1) part no. 851453 for fuel hose assy. (2).

Step	Procedure		
1	Remove hose clamp pliers from fuel hose assy.		
NOTE:	Thereby, the fuel contained in the lines flow out and flush the residual debris from the fuel line.		
	Be prepared with a suitable container and/or cloth to catch the outcoming fuel.

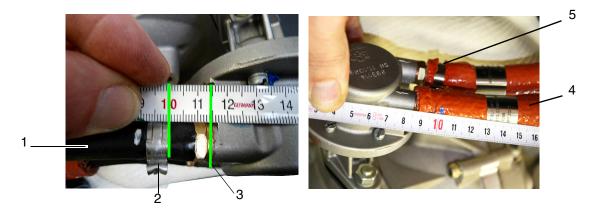
Fig. 9

The distance from the 1-ear clamp (2) to the nipple flange (3) has to be measured, so that the outer 1-ear clamp (5) can be mounted on the fire sleeve (4) in the correct position.

Distance measuring

Part	Function	
1	Fuel hose assy.	
2	1-ear clamp	
3	Nipple flange	
4	Fire sleeve	
5	1-ear clamp on fire sleeve

Step	Procedure		
1	Measure the distance at fuel hose assy. (1) from 1-ear clamp (2) to nipple flange sealing surface (3) and mark the fire sleeve (4) correspondingly.		
	NOTE: The clamp securing the fire sleeve should be as close as possible but without impeding on the fuel hose clamp

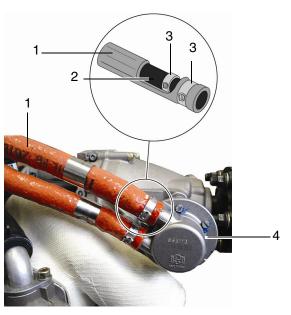
#### Fig. 10

#### **Graphic** Modification finished.

Part	Function
1	Fire sleeve
2	Fuel hose assy.
3	1-ear clamp
4	Fuel pump assy.
5	Drain line

Step	Procedure
2	Push fire sleeve (fuel inlet) to stop and mount 1-ear clamp (17.8-21.0 mm/0.70-0.83 in.) with suitable crimp pliers.
3	Repeat steps for fire sleeve (fuel outlet) (22.4-25.6 mm/0.88-1.01 in.).

A drain line must be installed, that in the event of a internal leak any fluid is drained to a suitable location/position. See therefore Installation Manual of the relevant engine type and SI-912-020.
